FishHawk Ranch CDD I & II
Pond Maintenance Inspection Report
November 2009

Conducted by: Joshua F. McGarry, Service Manager

Inspection Dates: 11/10/09, 11/24/09

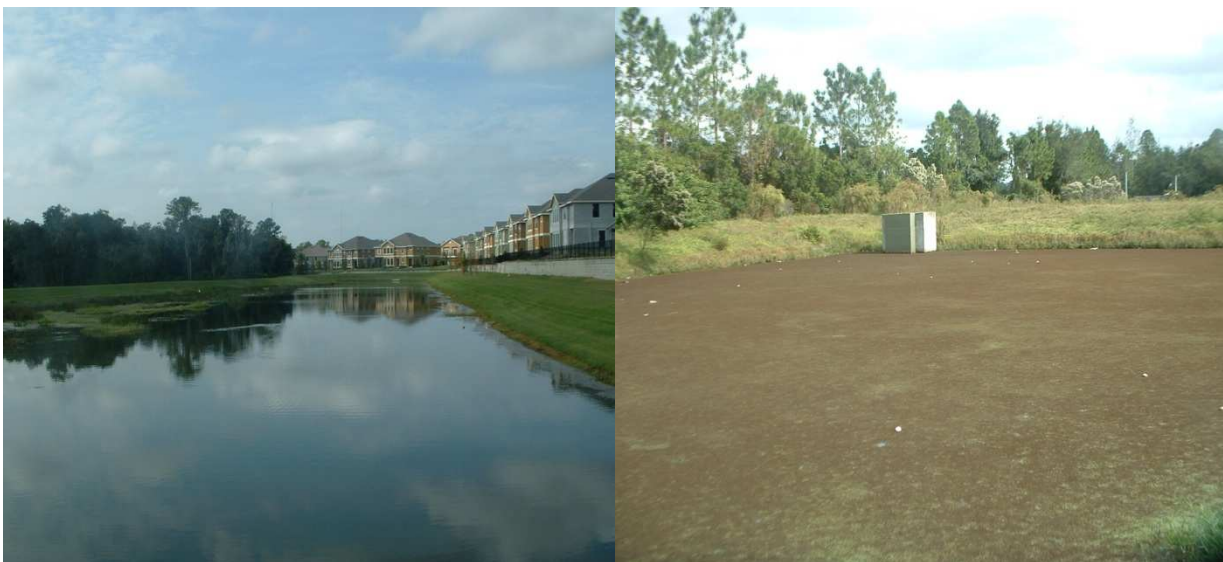
The cooler weather in November slowed the overall growth of all submersed and emergent weeds in FishHawk Ranch. The lower average water and air temperatures, along with shorter days have contributed to the decreased amount of algae. Floating weeds like Duckweed, Azolla and Salvinia tend to thrive in these conditions because of the lower water levels. The lower pond/lake levels are caused by the lack of rainfall and dryer conditions. A good example of Azolla is on pond 4 (lower right) in CDD 1. We have started a systemic treatment on this pond and we will continue to monitor and retreat for maximum results. Aeration is another option to consider using in pond 4. The constant movement of oxygenated water will discourage floating weed growth. Pond 100 (lower left) was over 50% covered with Azolla in October and has cleared because of the systemic treatments applied throughout the month.

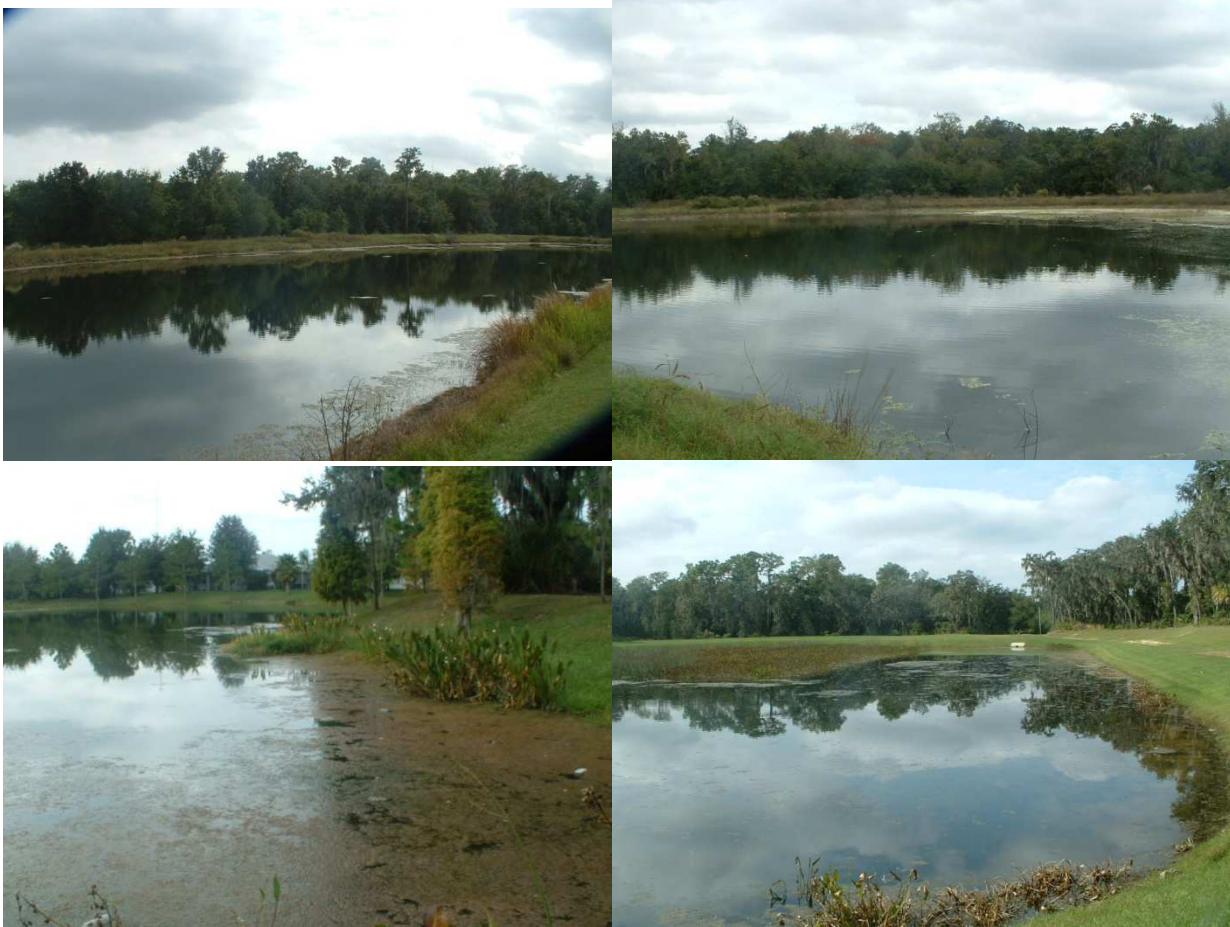
Pond 10 (upper left) was a priority in November. We had multiple treatments by both boat and ATV. We also did a debris removal for garbage in and around the pond. We are continuing to monitor #10 and this will remain a priority until the algae is under control. ASI has been targeting the floating weed called duckweed during September and October on pond 45 (upper right). We have been using a systemic treatment along with contact treatments to eliminate the problem. Our treatments are working as the pond is clearing up and looking much better. Pond 34 (lower left) has Slender Spikerush along with numbers 28, 29, 30, and 31, these ponds all flow into each other and that is why this submersed weed has spread. With limited flow due to less rainfall we will have better results with our systemic treatments on these ponds. In the picture of #34 you will notice the Spikerush is a dark brown, this is from our contact treatments and means that it is dying. The last picture is pond 105; this has a form of algae called Chara. The Chara is good for the clarity of the water but can become an eyesore when it tops out on the surface. This has been treated since this photo was taken and will show improvement.

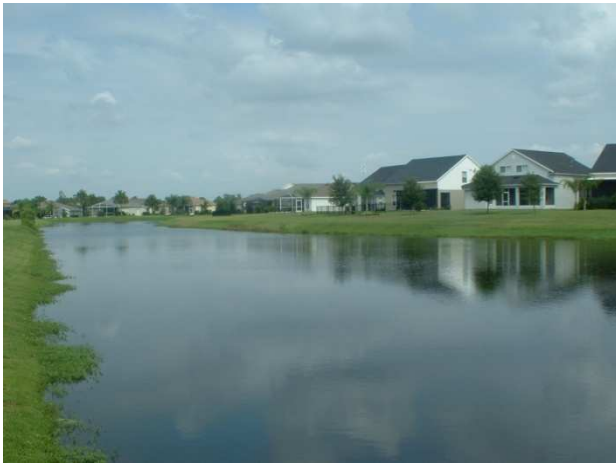
Before

The pictures below are a before and after picture of pond 52. The before was taken in mid September and the after was in late November. This site had significant alligator weed growth this summer, but with regular treatments and some cooperation with the weather, this invasive weed is under control.

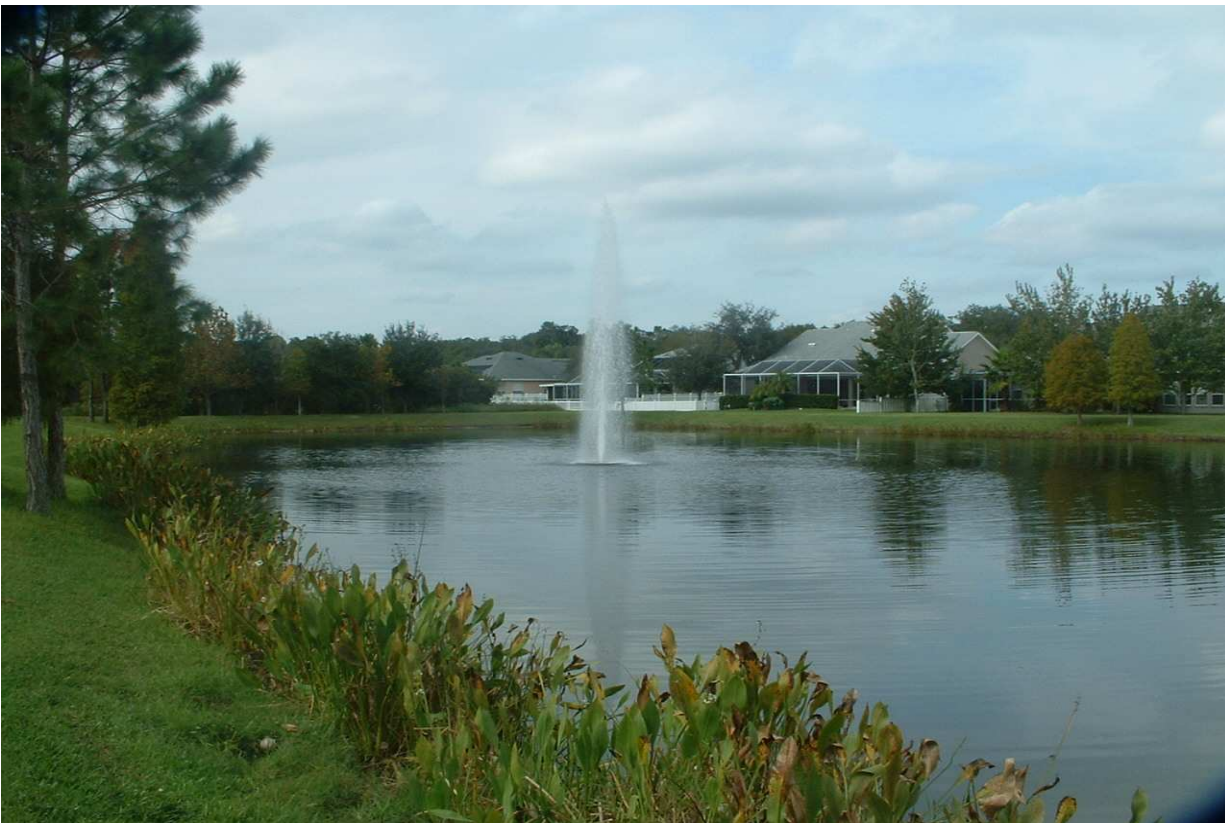
The pond pictured below is #7; this is the pond just outside of the Osprey Club and is one of the many beautiful ponds in FishHawk Ranch. This pond rarely has any problems, but on occasion will have a Planktonic Algae bloom that will make the lake look green in color. However, it is easy to treat with rapid results.
