## FishHawk Ranch CDD's I & II Wetland and Pond Maintenance Report October 2011

**Date of Inspection:** 10/12, 11/3

**Client:** FishHawk Ranch

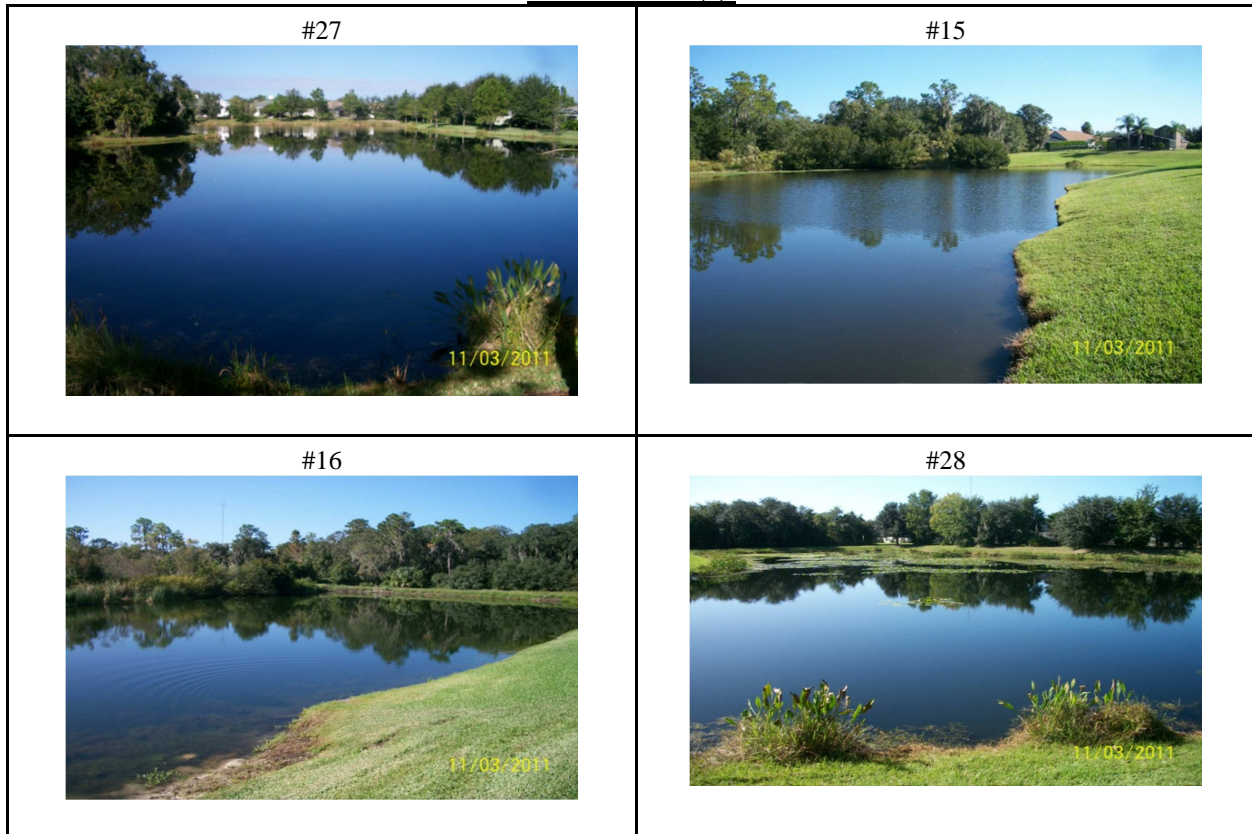
### Pictures of Site(s):

ASI has one technician on sight for each CDD, 7 times per month; this is proving to be very effective at controlling the overall growth in FHR. We will be utilizing a boat, John Deere Gators and our wetland crew to suppress the new growth in the littoral shelves and open water along with removing debris from the shoreline. Our technician's check in with Holly in the morning and at the end of the day to take care of any last minute issues that may arise. Ponds #27, #15, #16 and #28 are good examples of how a majority of the FishHawk Ranch ponds look. ASI uses these waterways as the bench mark for all of the ponds throughout FishHawk Ranch.

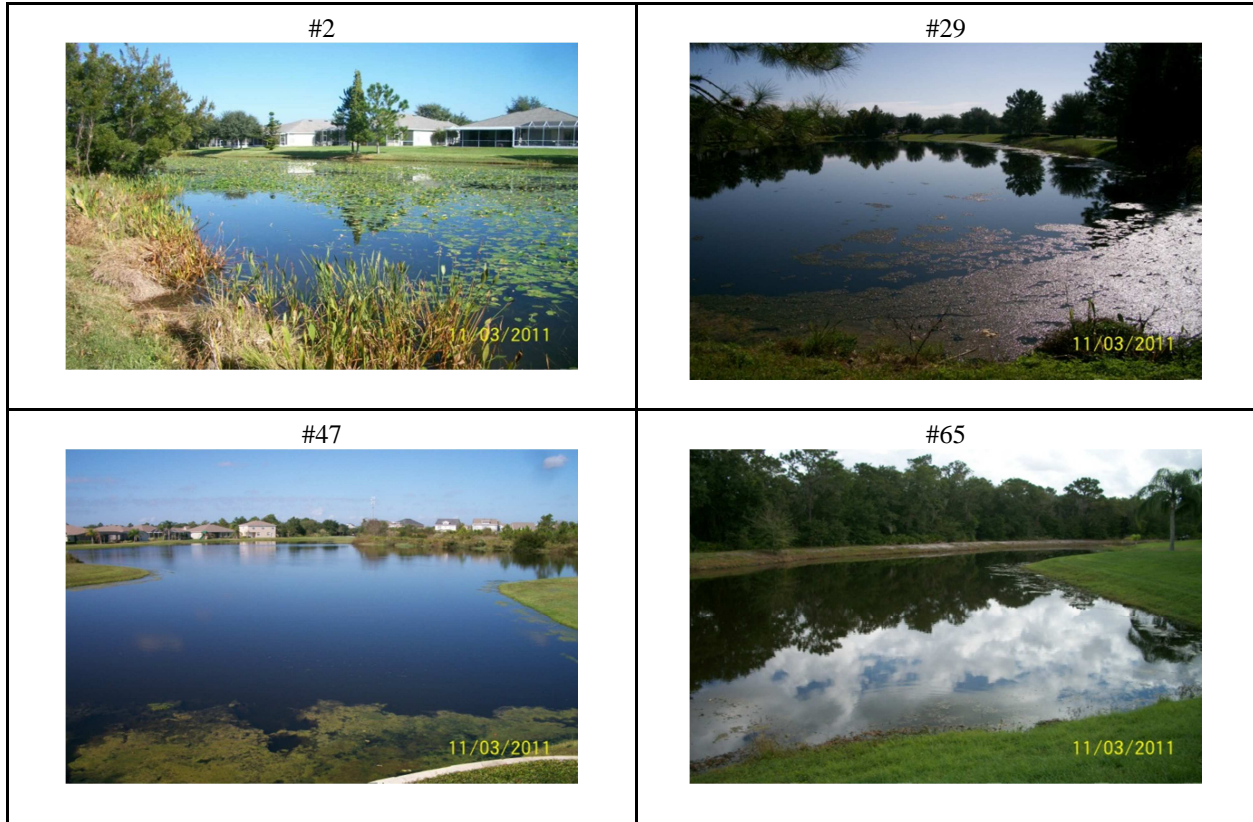
**Pictures of Site(s):**

The following ponds are currently being treated for various target plants and weeds; pond #2 is undergoing treatment for spatterdock lily. The goal is to thin them out and not eradicate them. The lilies are native so if we completely eradicate them, then it offers an opportunity for an invasive and less desirable weed to be introduced. During my inspection I observed surface filamentous algae on ponds #29, #47 and #65. These sites were treated immediately and the results will be noticeable in 10-14 days.

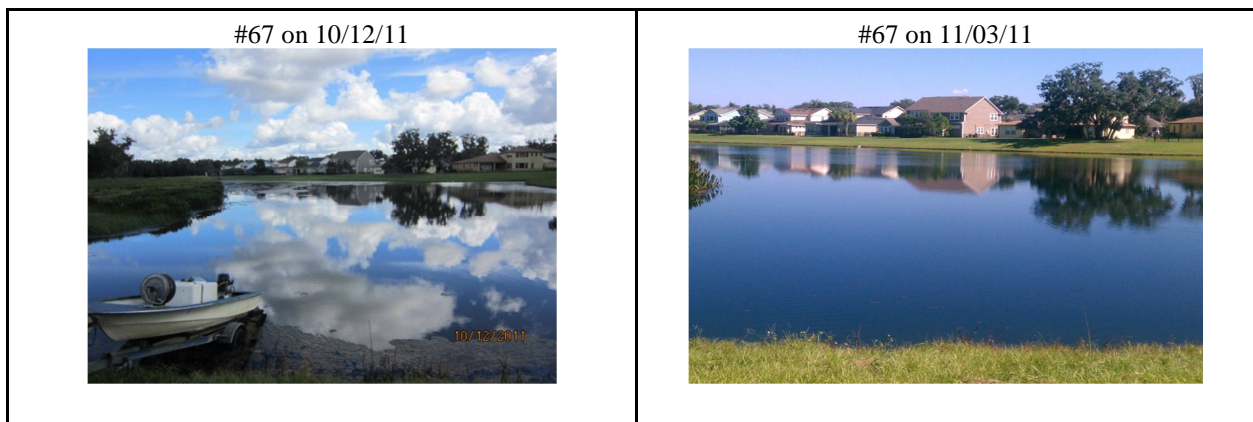
**Pictures of Site(s):**

A contact application for southern naiad and algae was done on 10/12 and I am pleased with the results. This treatment was applied by one of our boat spray rigs. The algae and submersed vegetation has been reduced to < 5% from 40% in a period of three weeks. The before and after pictures are below.

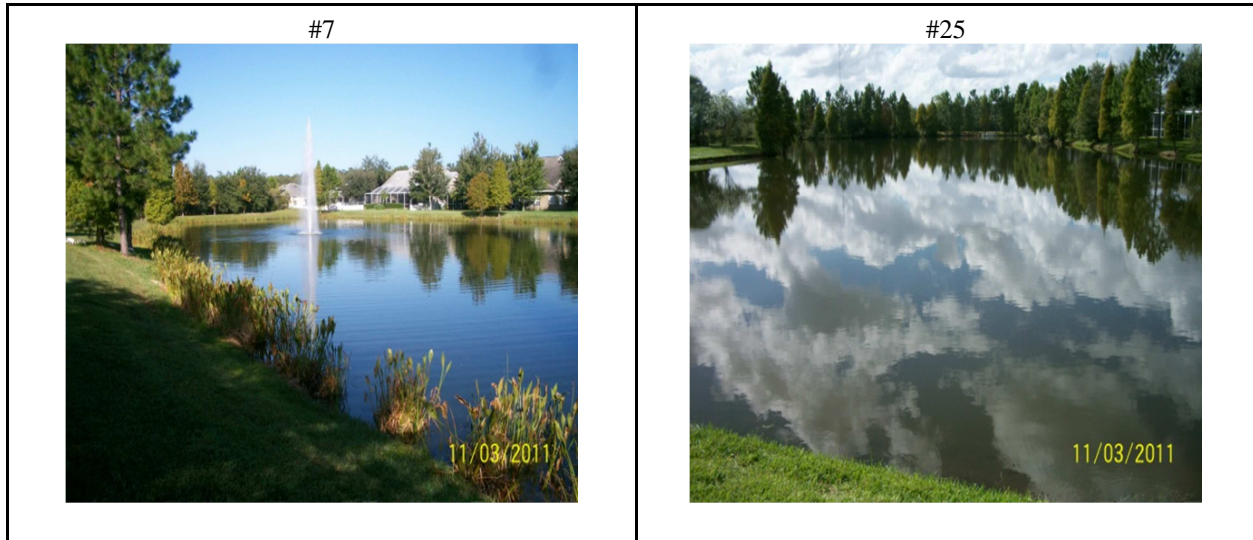
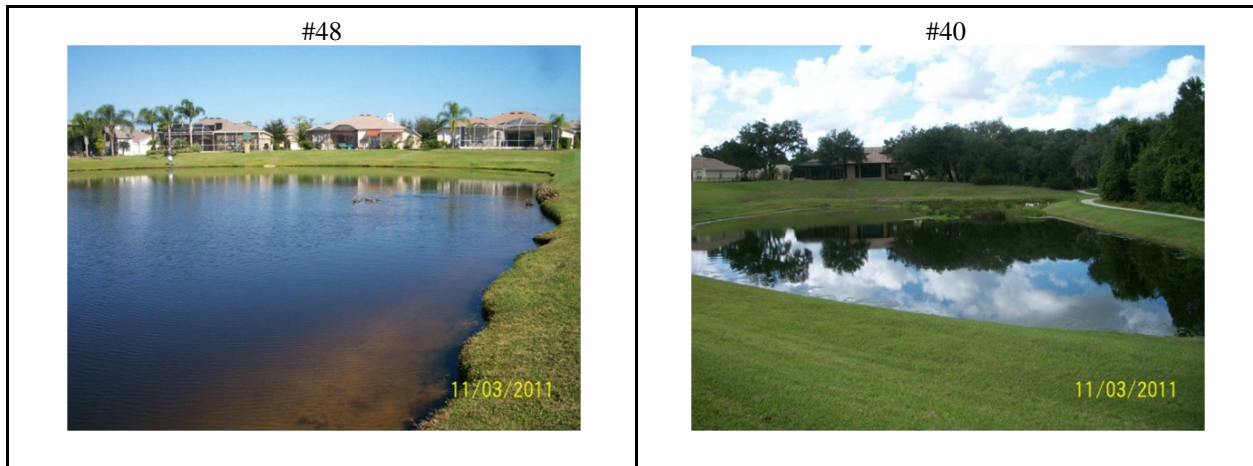
**Pictures of Site(s):**

In November, December and January ASI will be continuing to focus on detail work throughout FishHawk Ranch. We will be spot spraying out cattails and various other nuisance weeds in the littoral shelves. The littoral shelves are more accessible in the winter because of the low water levels. Overall, the ponds in FishHawk Ranch are in good shape and continuing to improve. Sites #7, #25, #48 and #40 are few more examples of the pond conditions in FHR.
